Date: July 10, 2015

SP80 Internal UHF Radio Troubleshooting

This support note describes how to resolve the problem about SP80 can't detect internal UHF radio.

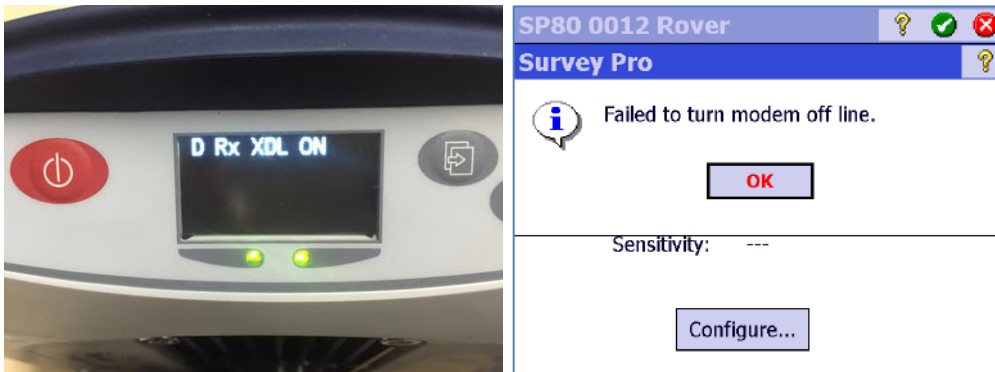
But sometimes SP80 can't detect internal UHF radio as below:

So following are the steps of troubleshooting:

- c. After succeed to connect the UHF radio, it need to check the baud rate which is displayed at the title of dialog. If it's not 38400 that need to change it to 38400 at the tab page of Serial Interface.

2. After changing the baud rate of radio port to 38400 if receiver still can't detect the UHF radio that need to check the baud rate of receiver internal Port D again by Ashcom.
 - a. At first, sending command \$PASHQ, PRT, D to query the current baud rate of Port D, if the message character of response is 7 means the default value is correct (38400bps).

- b. If not then sending command \$PASHS, PRT, D, 7 to set the baud rate of Port D to 38400.

3. Once above all operation have already been done but still can't resolve the issue, then go on checking SP80 front screen to see if the radio page existing or not. If not quite possible point is due to hardware like joint loose between ribbon cable and internal port D of receiver.
